## Product Change Notification

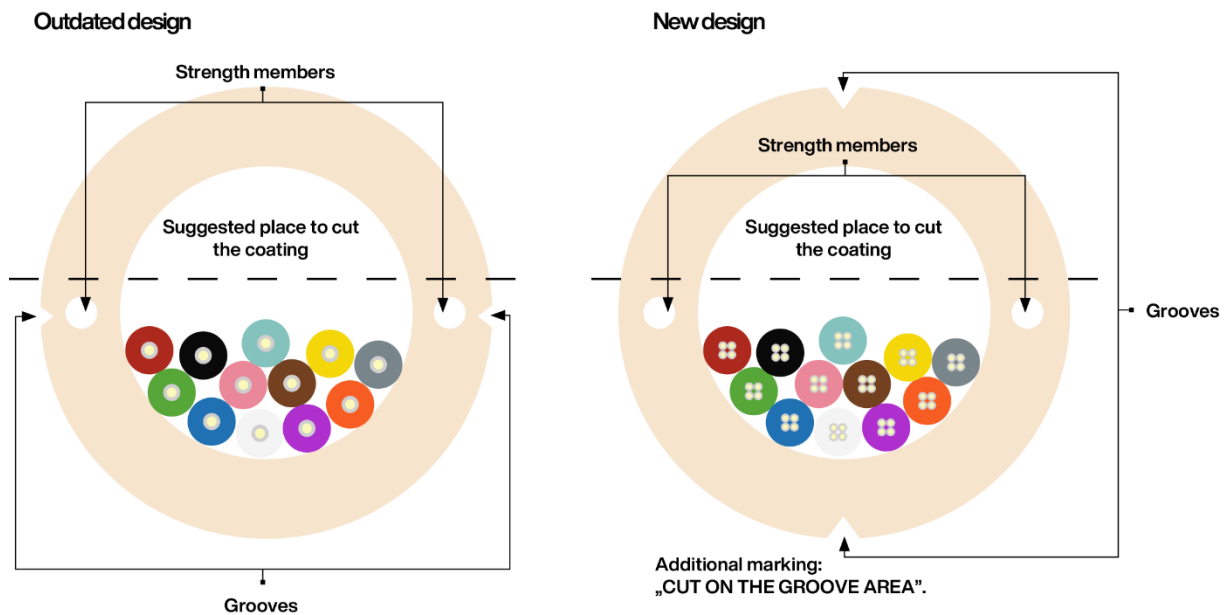
FIBRAIN Sp. z o.o. would like to inform about the design modification of fiber optic cables from the EAC group. Please note that the change relates to the position of the grooves in the cable sheath. The grooves have been offset from the reinforcement strength members by 90 degrees. According to the above, the line marked by the grooves indicates directly the place where the center of the window cutting tool should be placed in the cable. The described method of making the incision prevents from damaging strength members placed in the cable sheath.

The cables with the modification are marked with an additional marking: "CUT ON THE GROOVE AREA".

These changes do not affect parameters or mechanical properties of the cable.
